FLIGHT EXPERIENCE WITH TWO HIGH-SPEED AIRPLANES

HAVING VIOLENT LATERAL-LONGITUDINAL

COUPLING IN AILERON ROLLS

By NACA High-Speed Flight Station

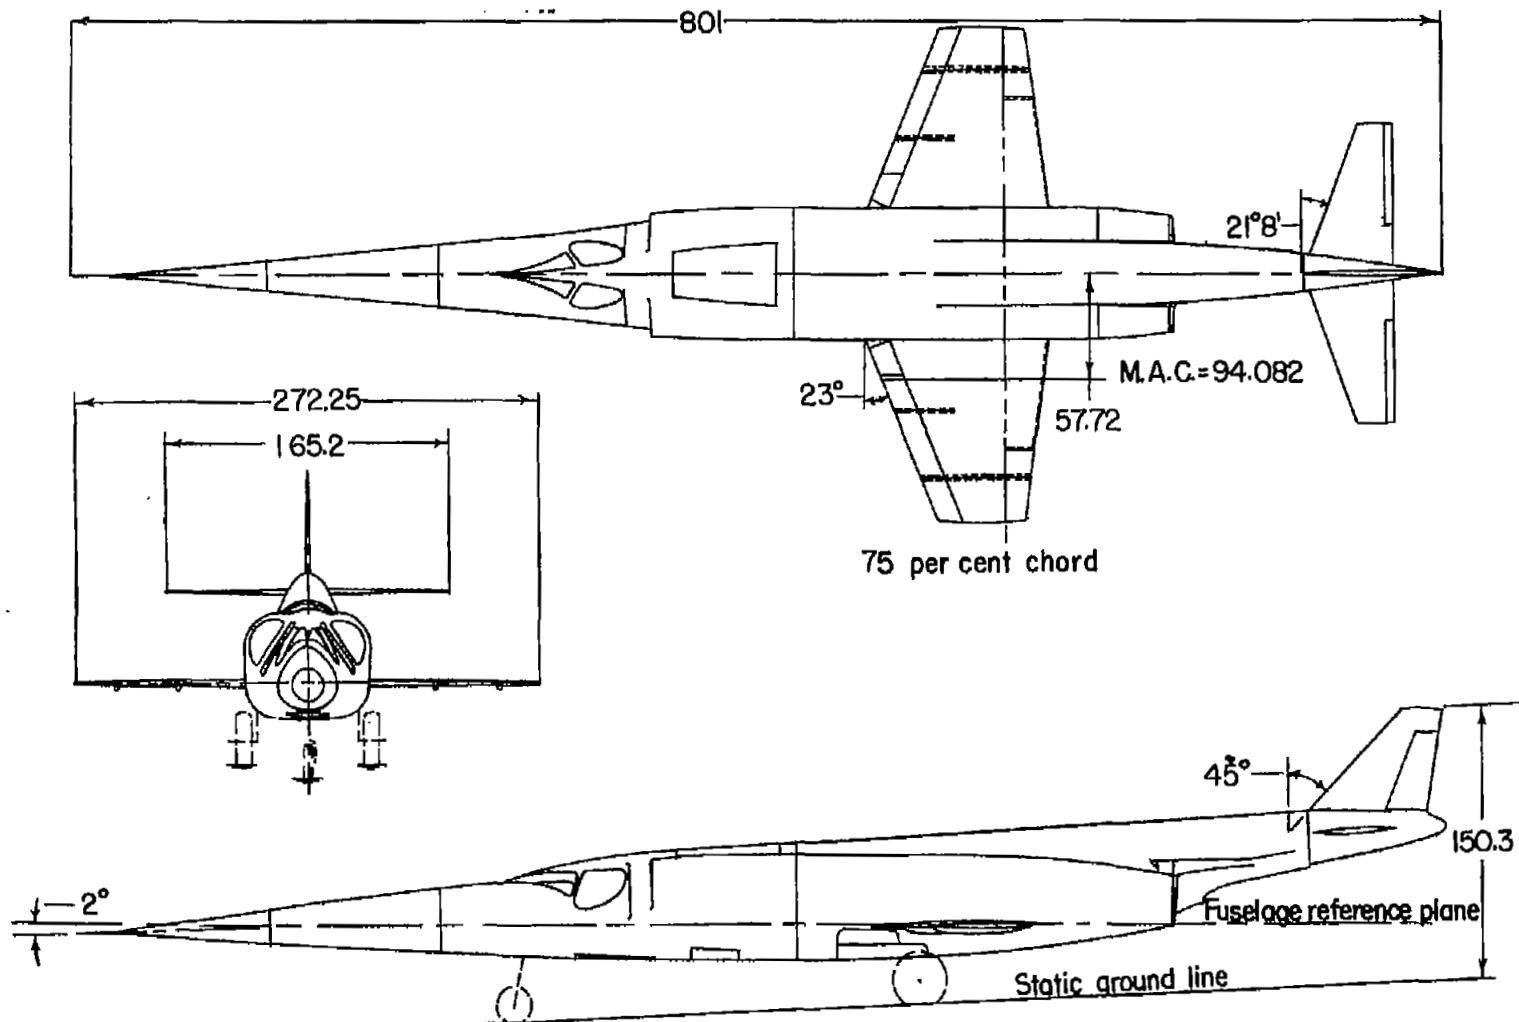
Figure 1.- A three-view drawing of airplane A. All dimensions in inches.

The mass and geometric characteristics of airplane A, the X-3 research airplane, are presented in table I, a three-view drawing is shown as figure 1, and photographs are shown as figure 2.

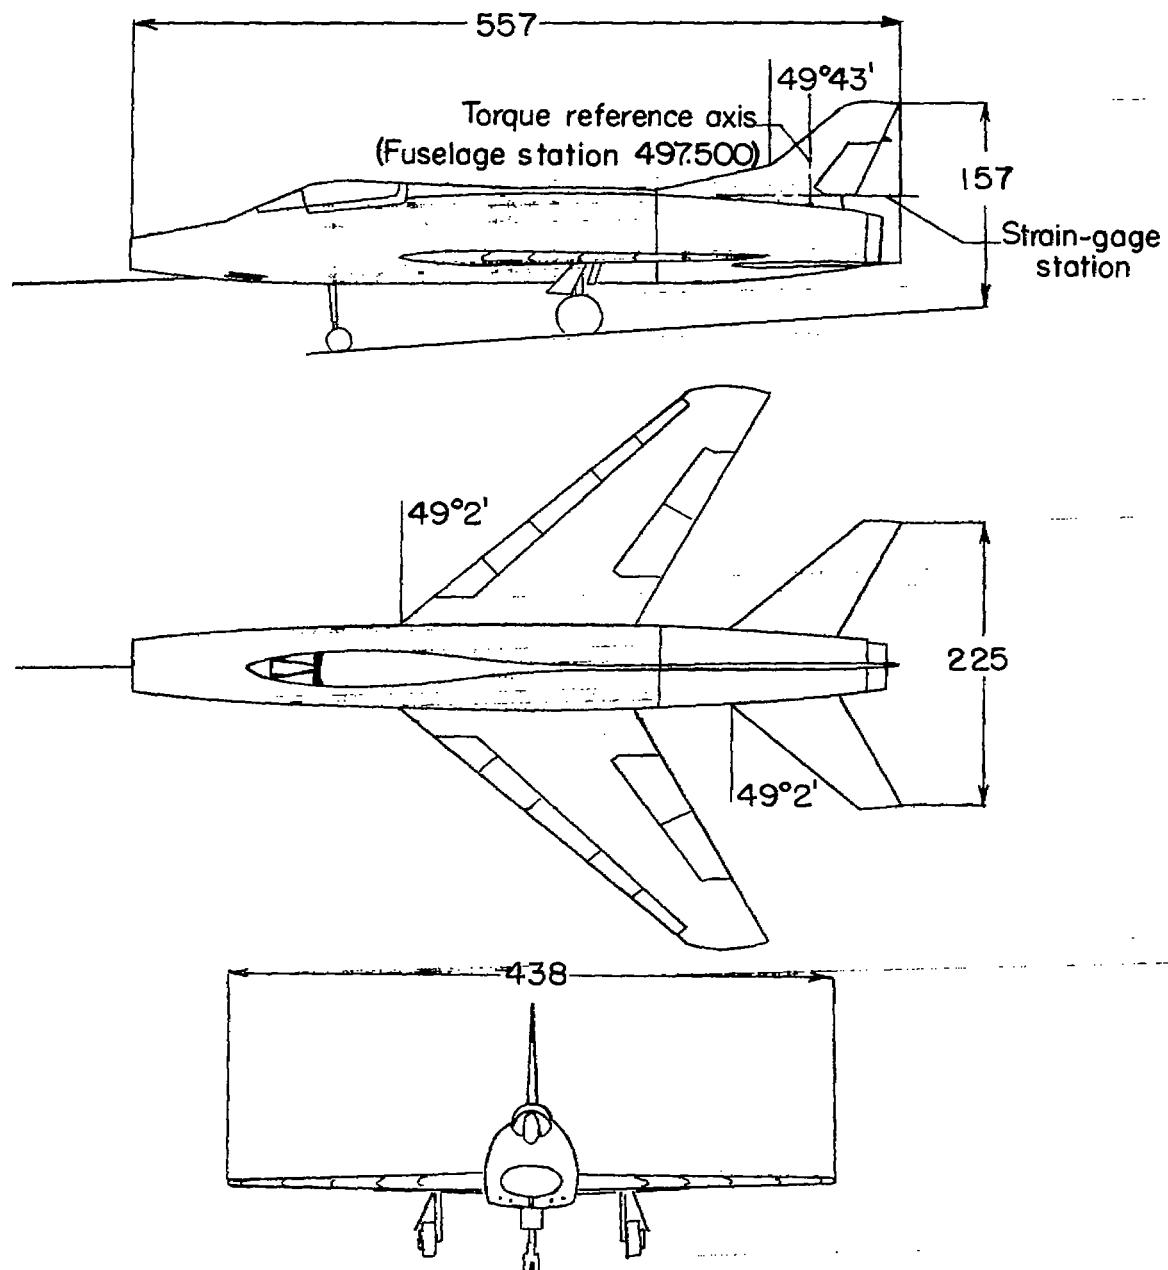
Figure 3.- Three-view drawing of airplane B. All dimensions in inches.

Airplane B is a fighter type, the mass and geometric characteristics of which are presented in table II. A three-view drawing is shown as figure 3 and photographs as figure 4.

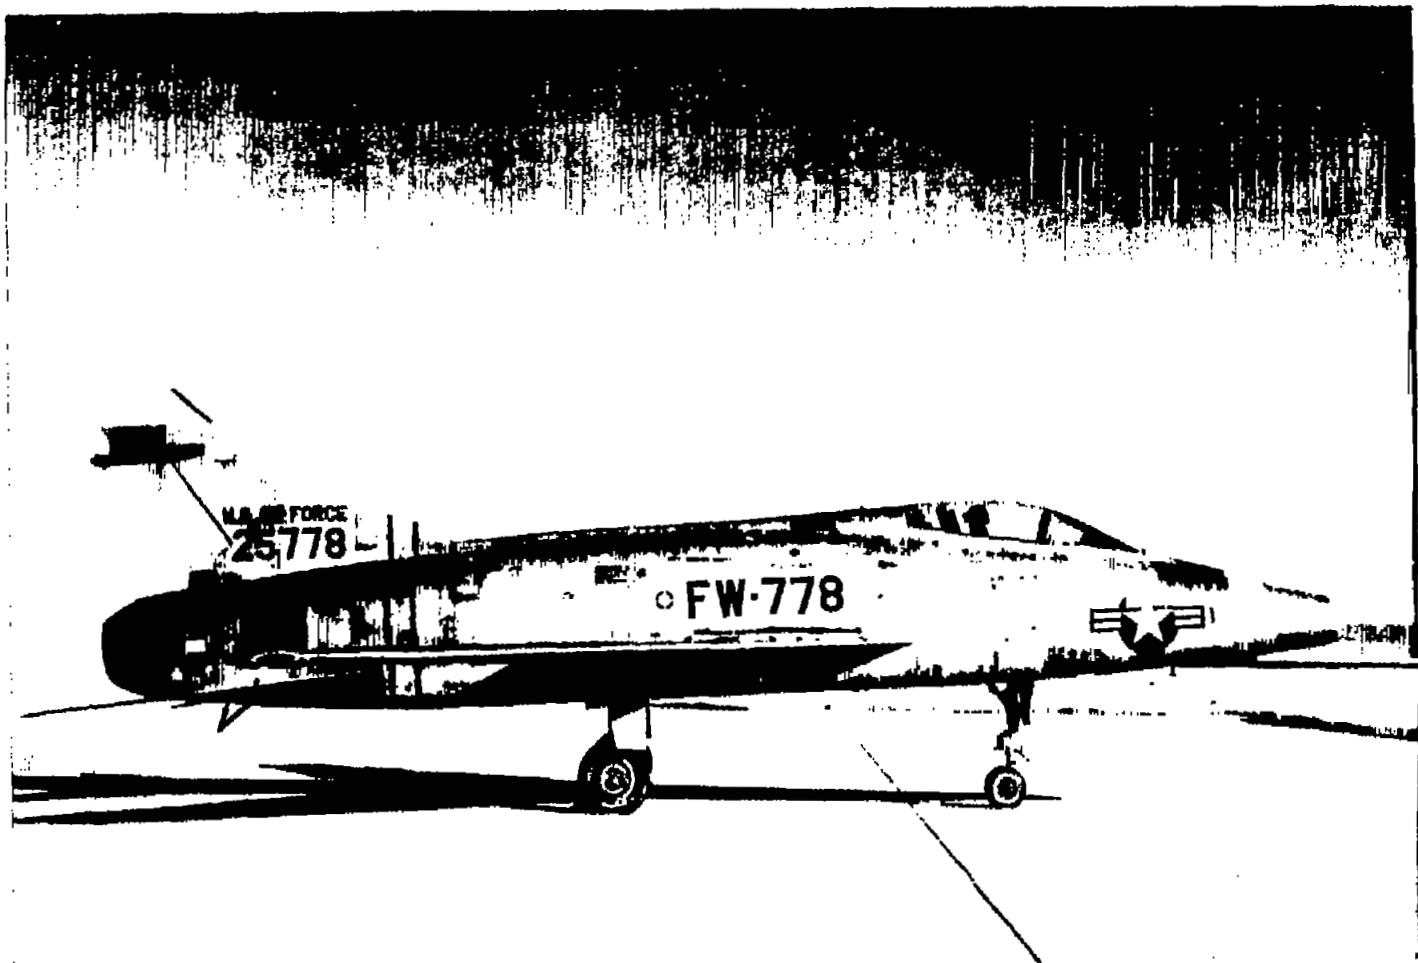
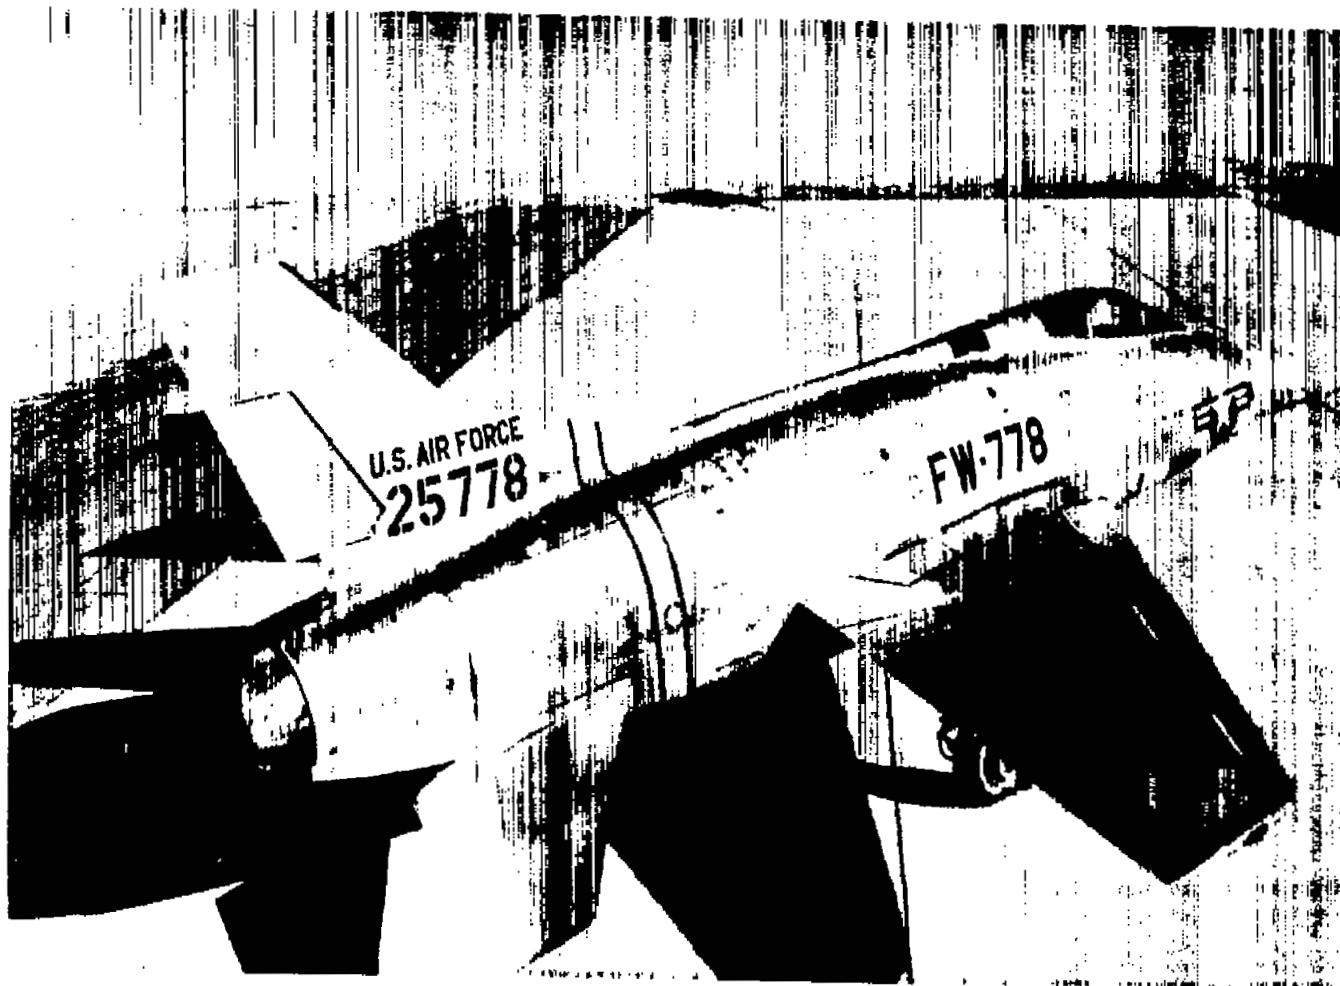
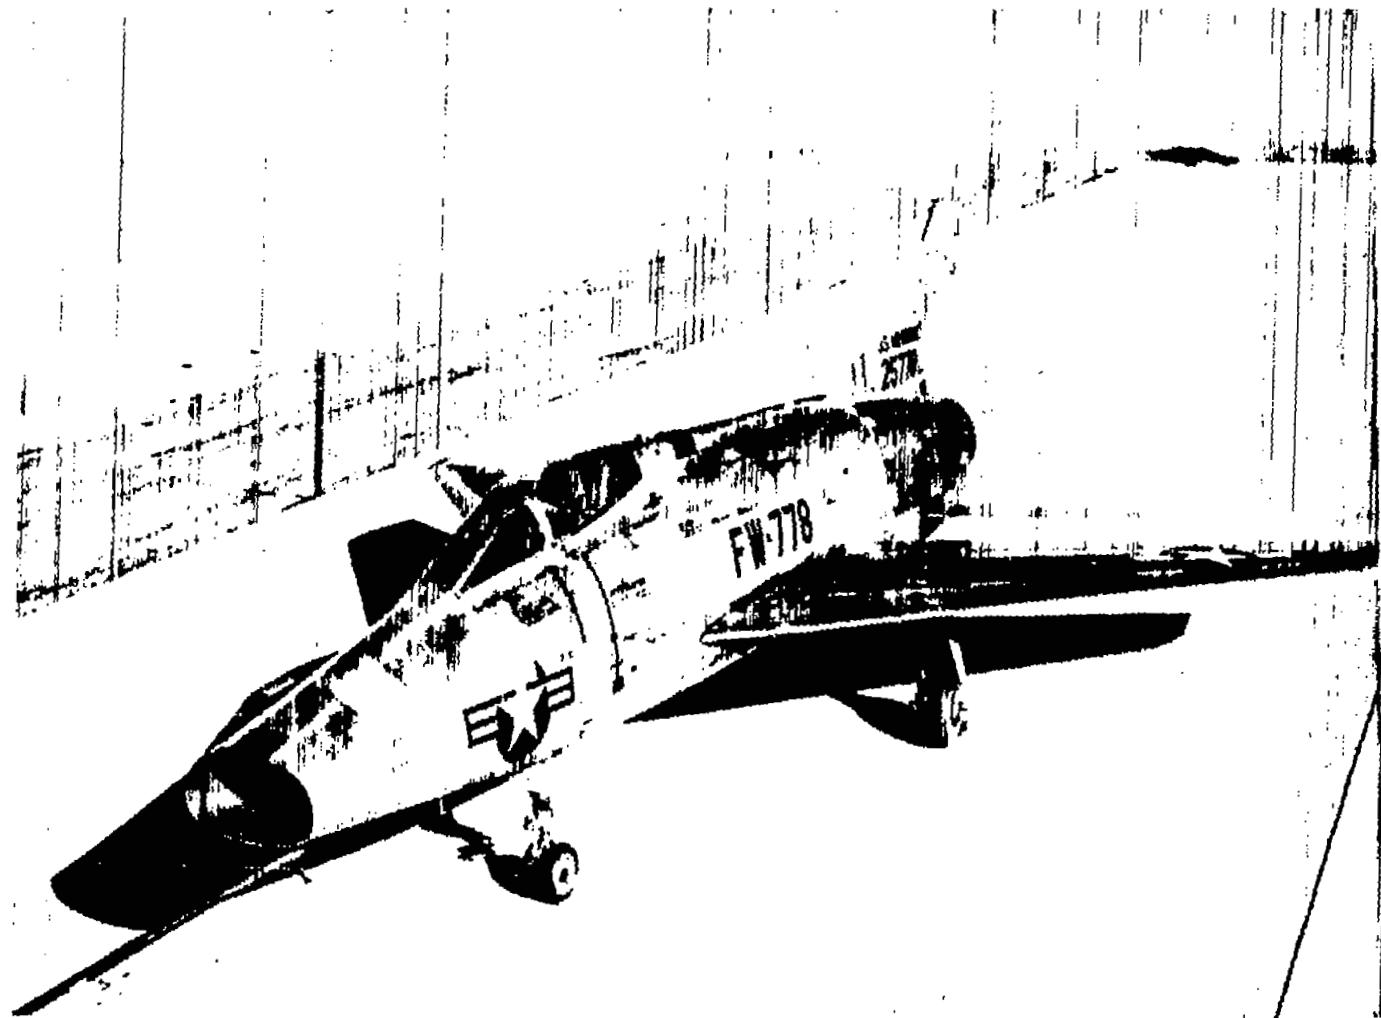
(a) Side view.

Figure 4.- Photographs of airplane B.

(b) Three-quarter rear view.

(c) Three-quarter front view.

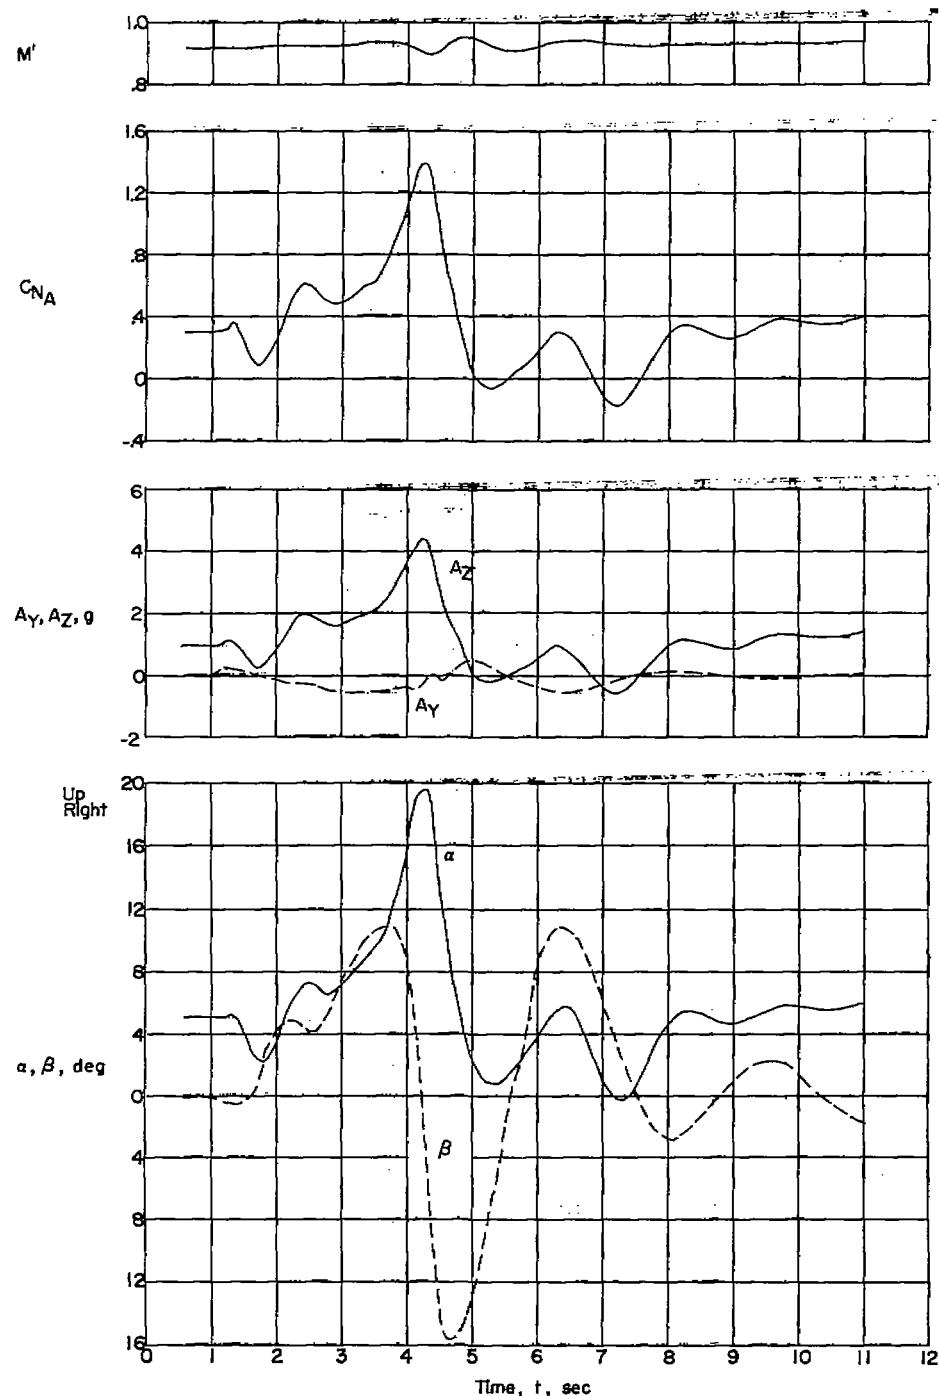
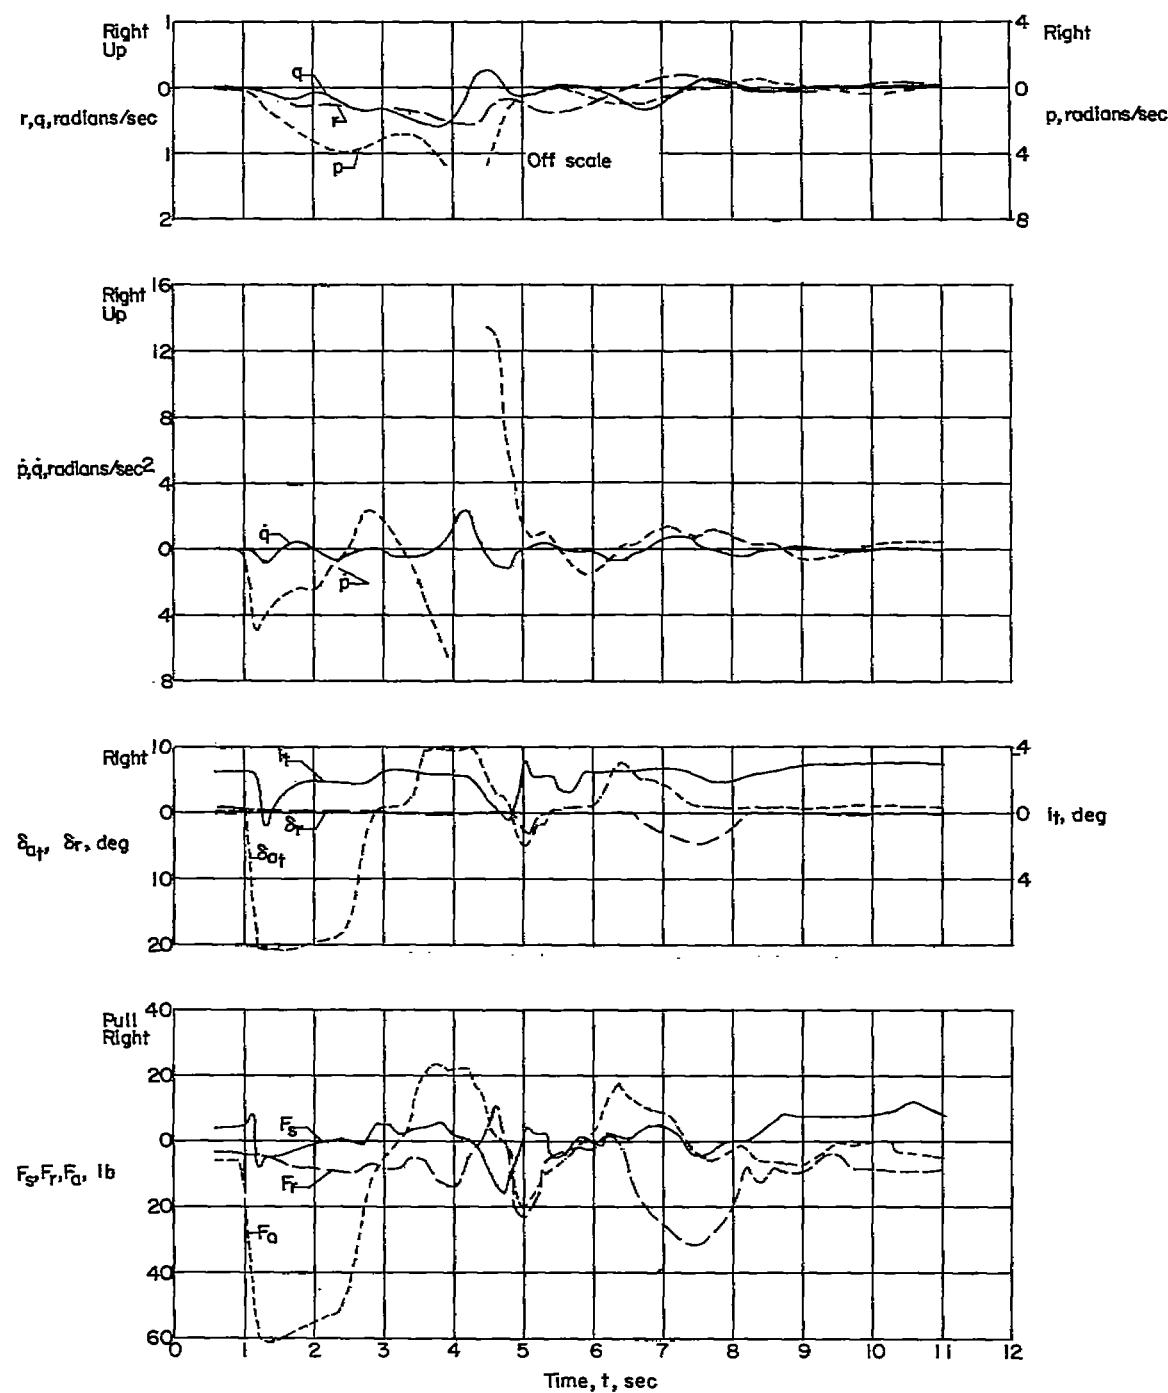
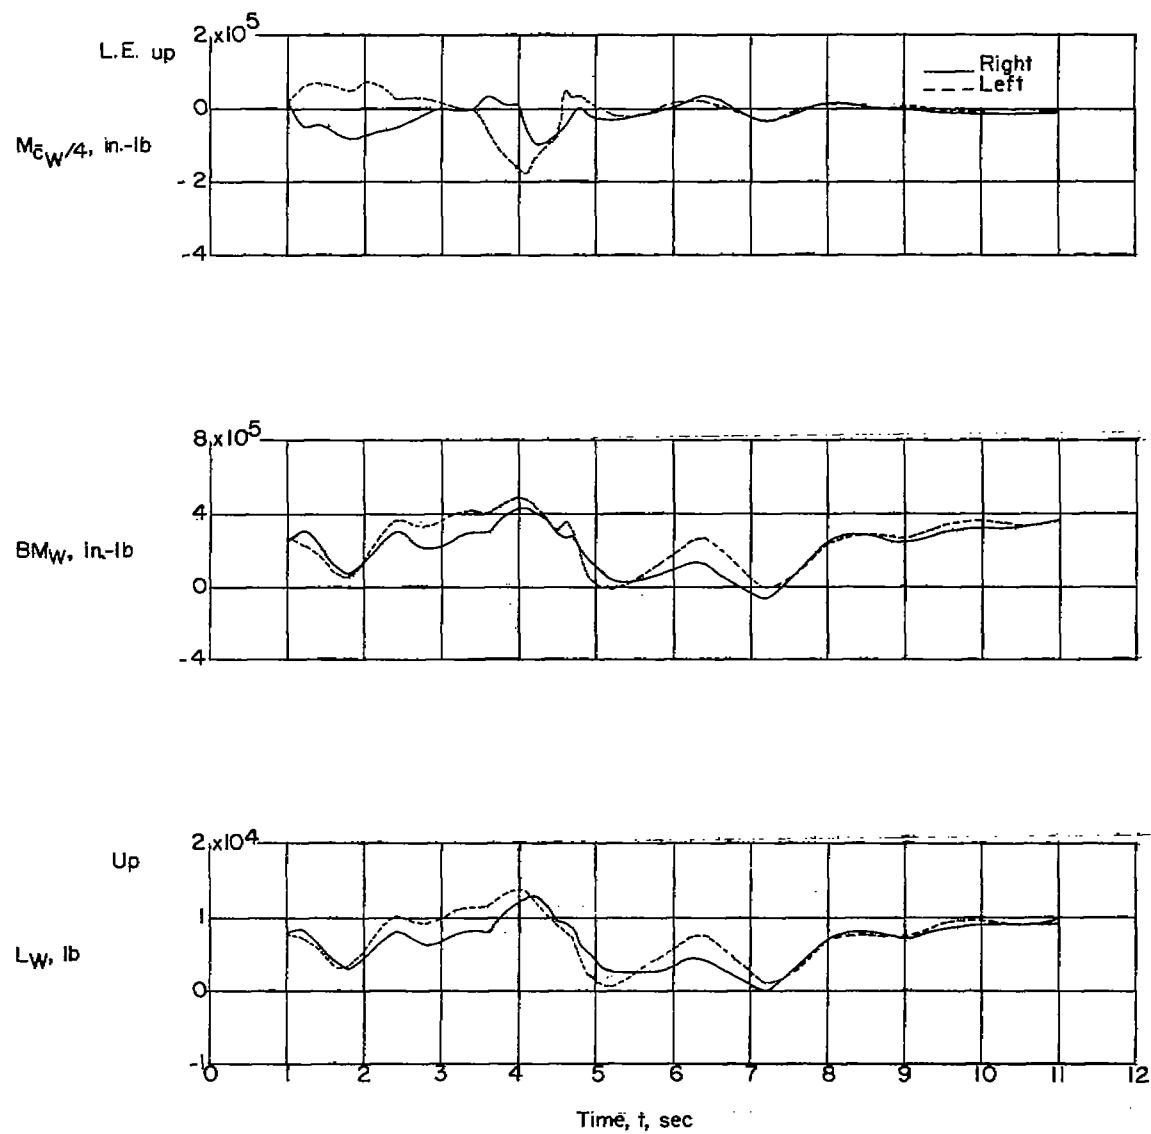
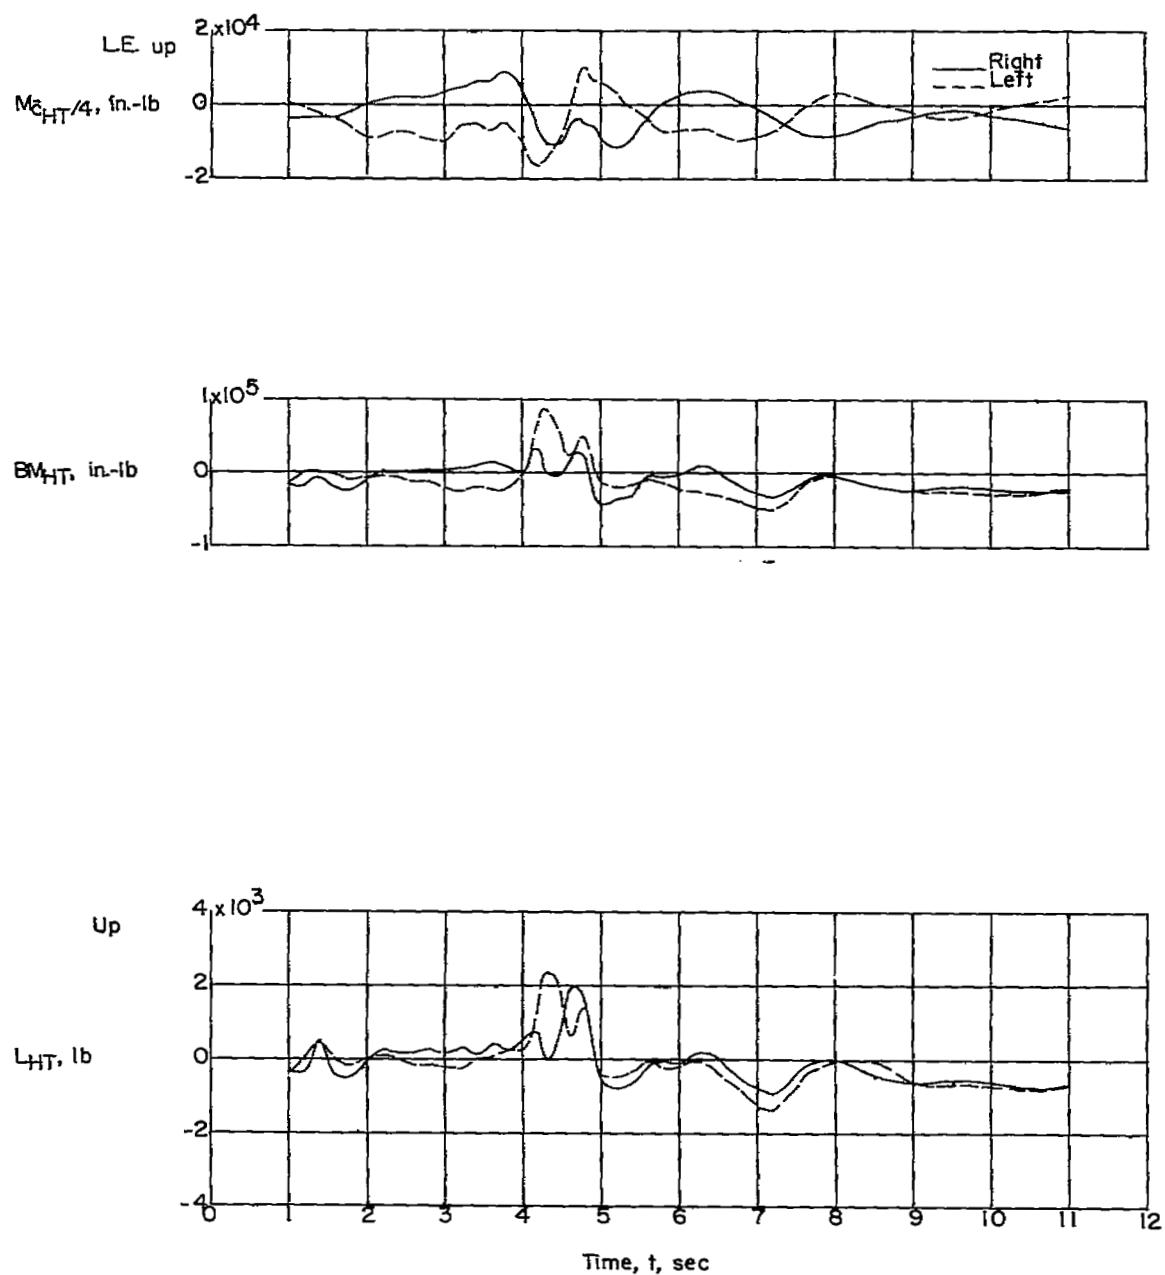
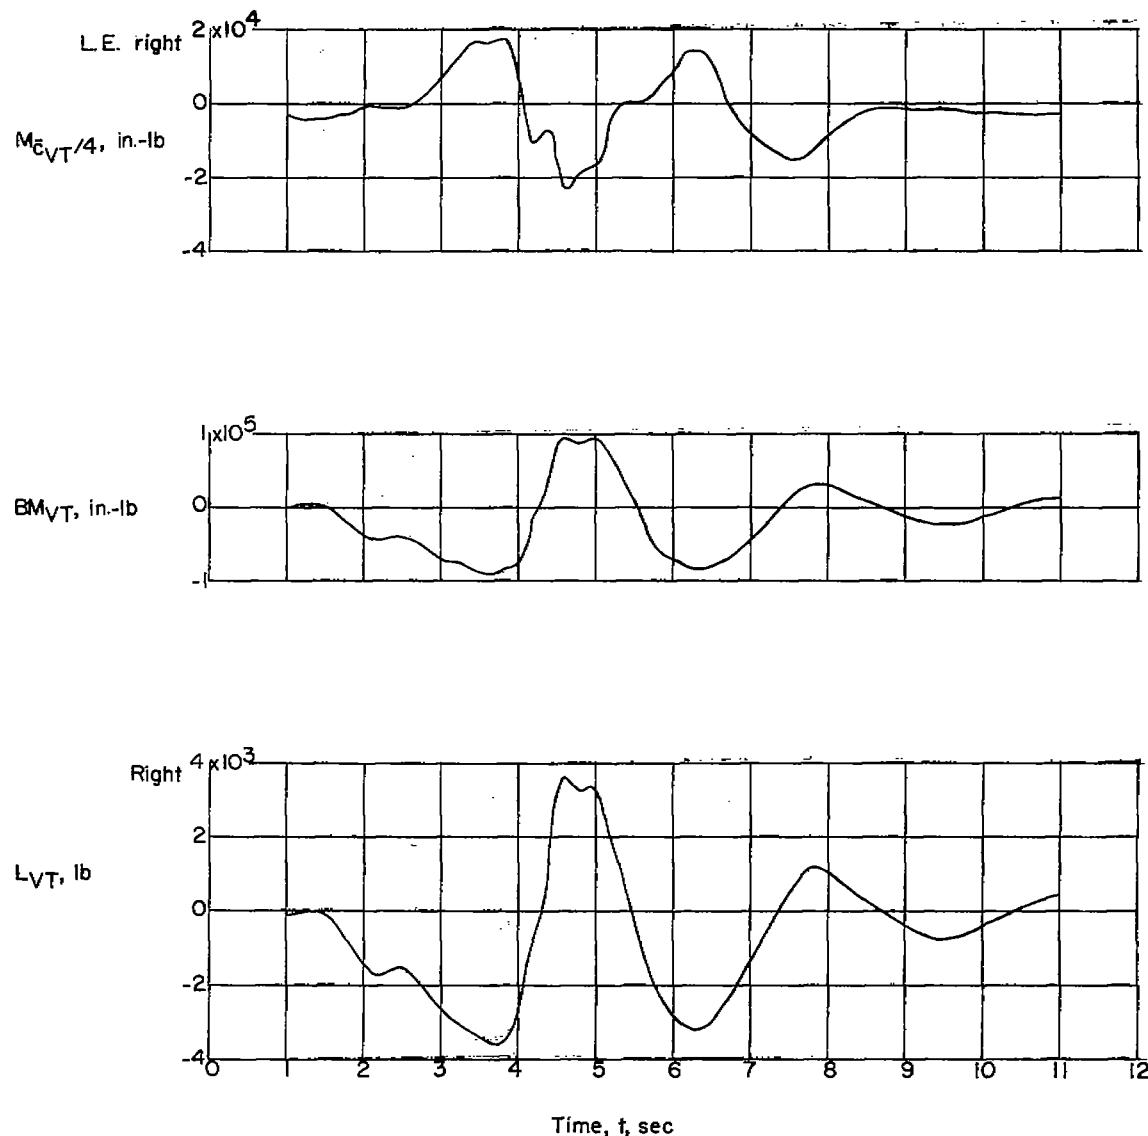
(a) Stability and control plots.

Figure 5.- Time history of quantities measured during an abrupt aileron roll with airplane A at $M \approx 0.92$. $h_p \approx 30,000$ feet.

(b) Stability and control plots.

(c) Wing structural loads.

(d) Horizontal tail structural loads.

(e) Vertical tail structural loads.

The time history of an abrupt left aileron roll for airplane A flying at a Mach number of about 0.92 at an altitude of 30,000 feet is presented as figure 5. While the ailerons are deflected for the aileron roll, a favorable sideslip angle is generated, together with a rather large increase in angle of attack. (The initial decrease in angle of attack is probably attributable to pilot stabilizer control input.) At time 3.8 seconds, even though the pilot is now applying 10° right aileron control, left rolling velocity increased and exceeded 5 radians/sec accompanied by violent pitching and sideslipping motions. During this uncontrollable phase of the maneuver, an angle of attack of 20° and left sideslip angle of 16° were encountered. It might be of interest to note that the onset of the violent maneuver coincided with the attainment of the angle of attack ($\alpha \approx 8^\circ$) at which unpublished flight data indicates the occurrence of reduction of longitudinal stability. Also, the angle of attack of 8° corresponds to the angle of attack at which a reduction in the measured wing lift slope occurs; therefore, large wing loads were not experienced at the maximum angles of attack (fig. 5(c)). After the primary rolling motion has subsided at $t = 5$ seconds, the large lateral and longitudinal motions damp fairly well.
